2023 Reserve Study & Maintenance Plan

Bella Vista Heights

Medford , OR

Regenesis Reserves

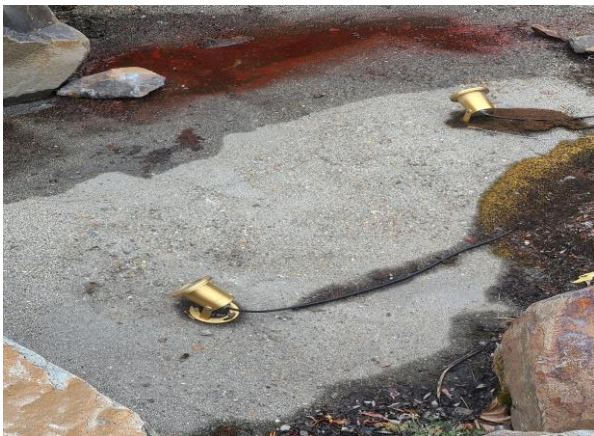
Lights-Exterior-Water Feature	7	Fixtures	\$ -	\$ -	2020	50	2070	48	Yes
<p>Comments: 2022: Advised to remove from report; board has voted to replace the water feature with plants.</p>									
Mailbox-Cluster	106	Units	\$ 140.00	\$ 19,581	2006	30	2036	14	Yes
<p>Comments: Budget assumes using existing concrete and setting all boxes up according to USPS regulations.</p>									
Paving-Asphalt- Crackseal, Sealcoat-Path	2,000	Sq.Ft.	\$ 0.30	\$ 624	2019	5	2024	2	No
<p>Comments: 2022: Advised pathway includes Tract B only advised that Tract C pathway has been abandoned and will not be maintained.</p>

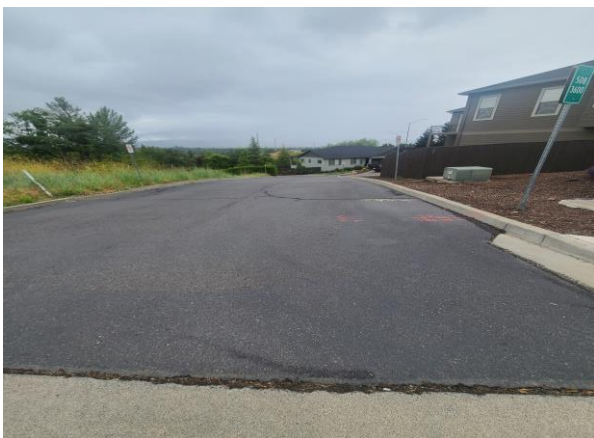
Item Description	# of Items	Unit	Current Item Cost	Future Replacement Cost	Year Built	Useful Life	Year Replace	Life Left	One Time?
Paving-Asphalt-Overlay	79,470	Sq.Ft.	\$ 2.25	\$ 265,699	2012	30	2042	20	Yes
<p>Comments: Under average traffic conditions, and regular and adequate cycles of repair, crack seal and sealcoating, a properly installed asphalt pavement should last 30–40 years. Heavy truck traffic like garbage trucks can accelerated damage to the traffic lane. Sealcoating should be applied within 2 years of installation date.</p> <p>2022: Advised that pavement responsibility is limited to Carino Drive Tract F (17,877 sq. Ft), Sorrento Lane Tract E (6,521 Sq. Ft.) and, Camina Drive Tract G (6,572 Sq.Ft.) La Strada Circle (48,500 Sq. Ft.)</p>									
Paving-Asphalt-Overlay-Path	2,000	Sq.Ft.	\$ 2.25	\$ 6,687	2012	30	2042	20	Yes
<p>Comments: 2022: Areas observed that will need replacement sooner, replacement work can be paid from this budget.</p>

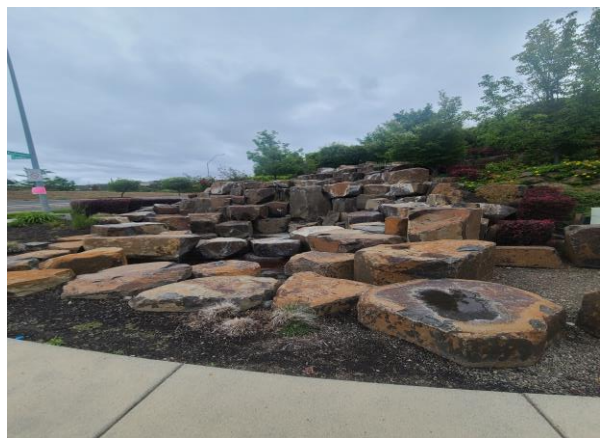
Storm Drain- Maintenance	1	Total	\$ -	\$ -	2022	50	2072	50	No
<p>Comments: To be completed as needed and paid from Operating Budget.</p>									
Water Feature - Motor	2	Total	\$ -	\$ -	2019	50	2069	47	Yes
<p>Comments: 2022: Advised to remove from report; board has voted to replace the water feature with plants.</p>									
Water Feature - Pumps	2	Total	\$ -	\$ -	2021	50	2071	49	Yes
<p>Comments: 2022: Advised to remove from report; board has voted to replace the water feature with plants.</p>
